U. S. ARMY AVIATION SYSTEMS TEST ACTIVITY EDWARDS AIR FORCE BASE, CALIFORNIA 99528

SUBJUCT: 6H-58A Autorotational Evaluation, USAASTA

SAAS (A Project No. -71-46

PACKCINOUNID Several recent instances of tail-boom buckling have occurred after an autorotational touchdown in the OH-58A helicopter. These occurrences prompted the US Army Aviation Systems Command (AVSCOM) light observation helicopter (LOH) Project Manager to enter into a product improvement program (PIP) with Bell Helicopter Company (BHC) to define the problem and recommend a solution. This PIP task included computer studies, a shake test, and flight testing of a structurally instrumented OH-58A helicopter. The results of the PIP task, to date, indicate that the tail-boom buckling resulted from a resonant condition between the main rotor and the natural frequencies of the fore and aft pylon mode and the tail boom. This resonant frequency, 5 hertz, was likely to occur at high blade angles (100-percent collective) and low rotor speed (150 rpm) and was associated with large main rotor flapping excursions. Three solutions were considered: (1) change the natural frequencies of the fore and aft pylon mode and/or tail boom, (

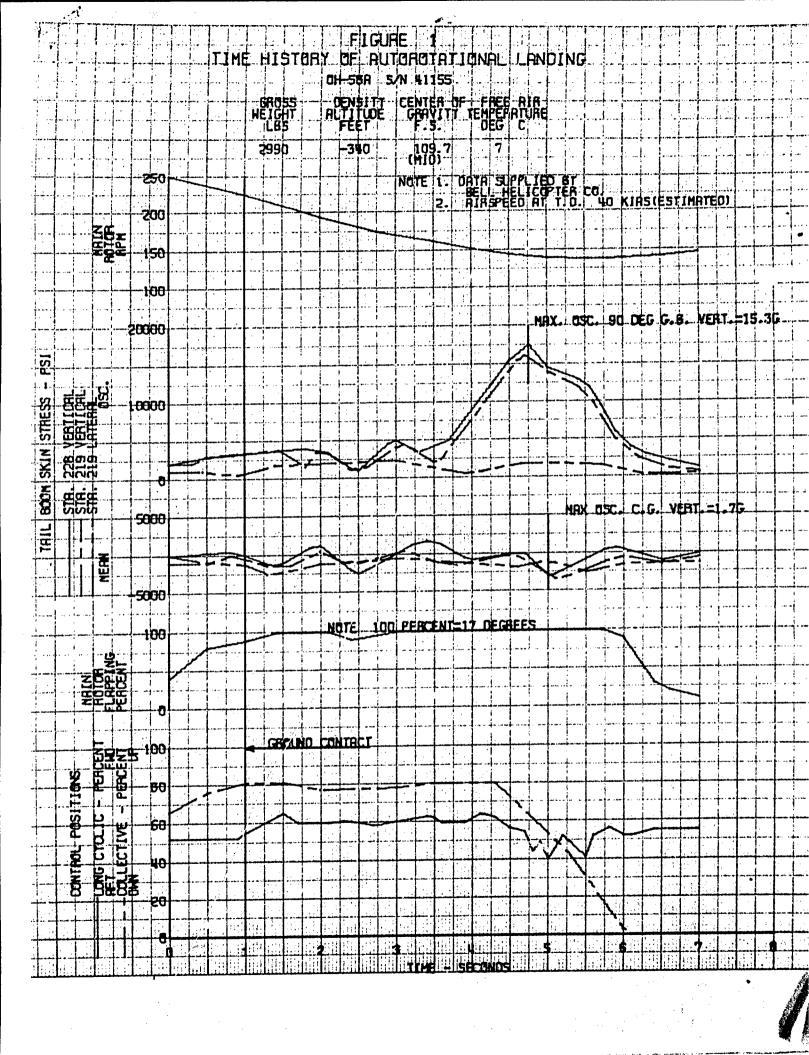
- Tail-Boom Resonance. A time history of an autorotational landing is presented in figure 1, inclosure 2. Shown in these data are the conditions under which tail-boom resonance was encountered during tests at the BHC flight test facility. The horizontal touchdown velocity at the time of the occurrence of the tail-boom resonance was estimated to be 40 knots. This airspeed was in excess of touchdown speeds which are normally used during flight operations. The structural loads experienced during this incident were not severe enough to cause failure of the tail boom; however, a 6-inch crack developed in the fiberglass fairing just forward of the tail-boom attaching point. As evidenced by the flight test data, the 80-percent restriction of collective control travel did not eliminate the excitation of tail-boom resonance. It did, however, extend the touchdown airspeed envelope within which tail-boom resonance did not occur. Immediate action should be initiated to eliminate the tail-boom resonance deficiency. As an interim measure to reduce the incidences of tail-boom resonance during autorotational landings, flight test techniques developed during USAASTA Project No. 69-16 (ref 4, incls 1) should be employed. Use of these techniques results in touchdown with rotor speed remaining in excess of 200 rpm. To demonstrate these techniques, a USAASTA test team should be sent to the Continental Army Command (CONUS) training sites. The following "WARNING" should be incorporated in the OII-58A operator's manual:

Touchdown autorotations with rotor speed below 200 rpm may result in tail-boom resonance.

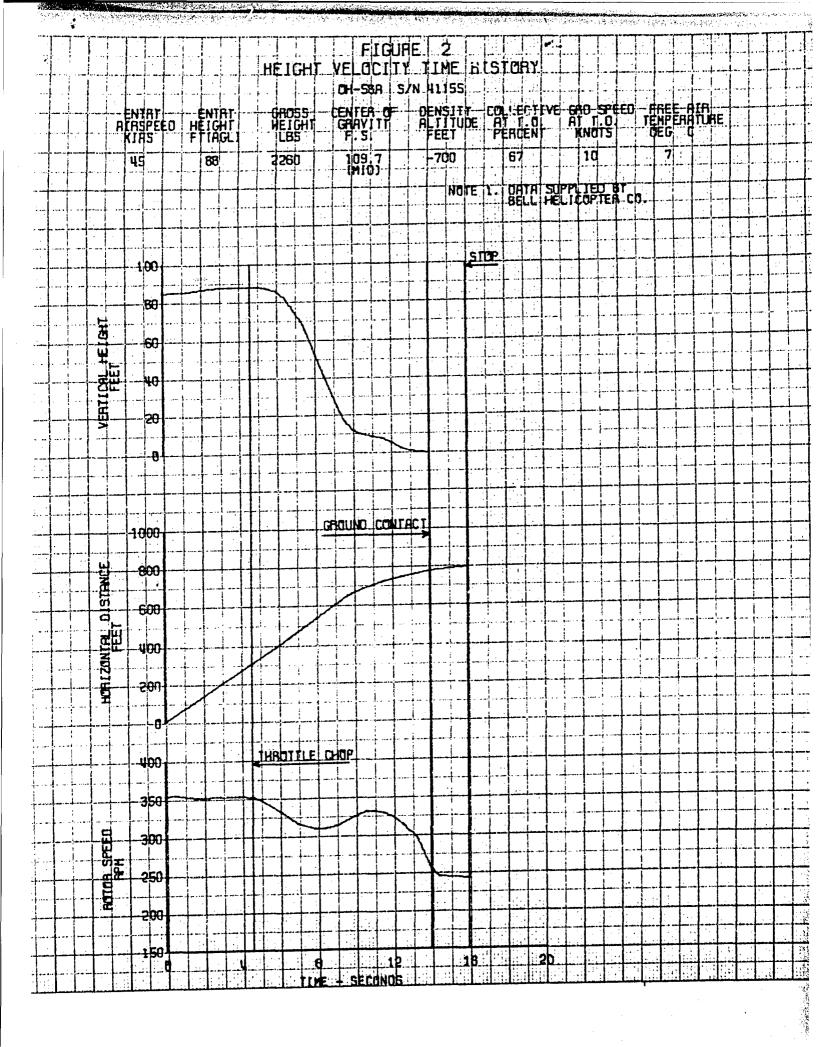
- (1) Qualitative test results indicate that the reduction of collection control travel had little or no effect on the II-V characteristics of the OH-58A where the conditions tested at the BHC facility. The test conditions are shown in able 1. Figure 2, inclosure 2, shows a typical H-V maneuver and denotes actual conditions at entry and termination of the maneuver. As shown in this figure, the rotor speed at ground contact is in excess of 250 rpm.

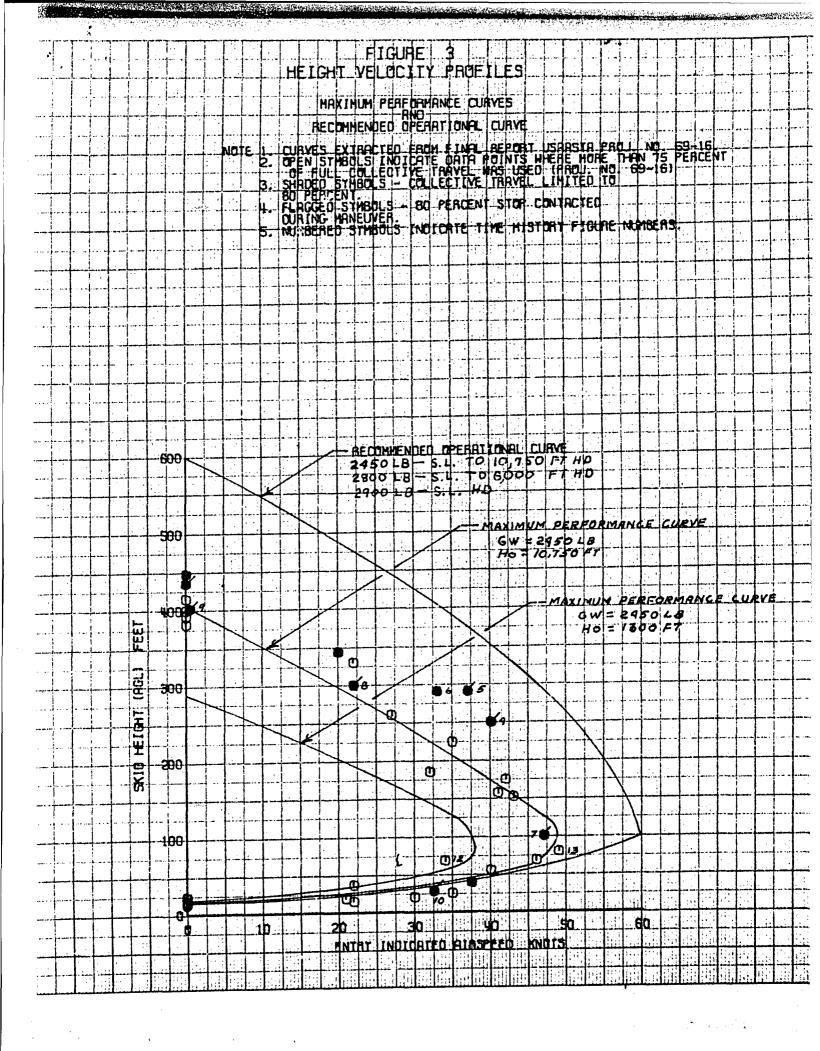
- (2) Incorporated in figure 3, inclosure 2, are data collected during recent high-altitude tests with the collective control restricted to 80 percent of full travel. These recent data indicate that the H-V characteristics of the OH-58A are degraded at density altitudes greater than 5,000 feet. Also shown in figure 3 are the near maximum performance and the recommended operational curves generated during USAASTA's previous H-V test program, Project No. 69-16 (ref 4, incls 1). The techniques utilized during the recent test program were the same as those developed during the conduct of Project No. 69-16.
